TECHNICAL REPORT GL-81-12

BOMB CRATER REPAIR TECHNIQUES FOR PERMANENT AIRFIELDS

Report 2
SERIES 2 AND 3 TESTS

Report 2 of a Series
October 1985

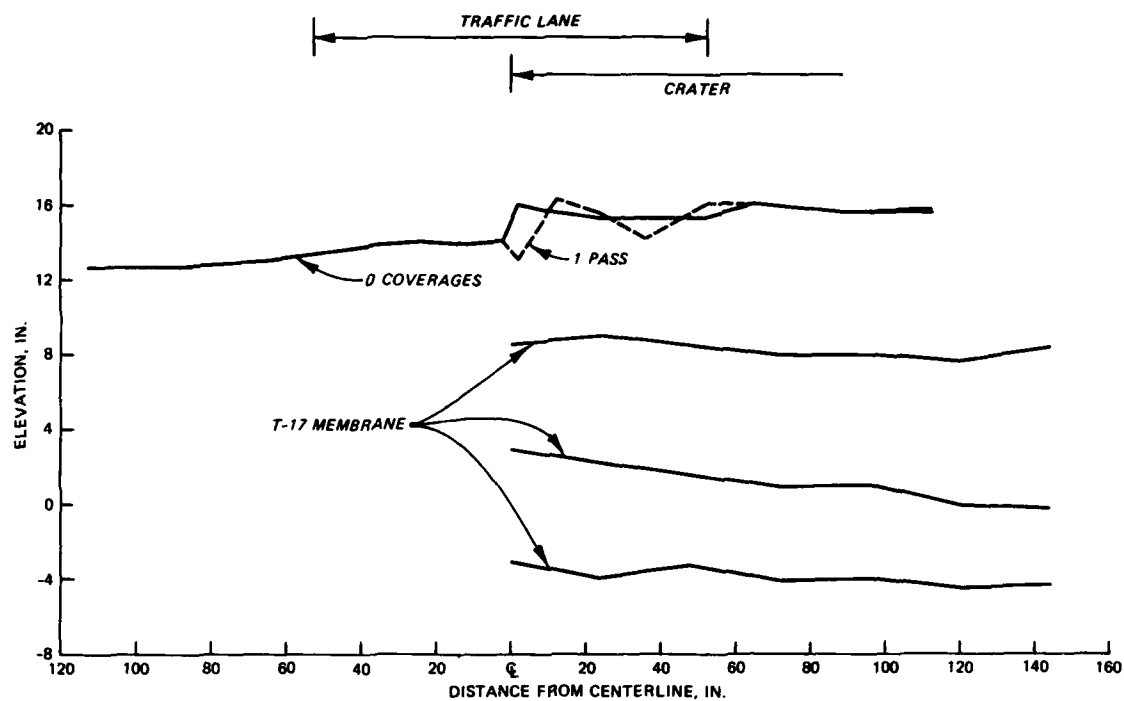
Figure 5. Cross section, crater 1, lane 1

38. Lane 1. Photo 52 shows the T-17 membrane in place over the WES blended material, prior to traffic. The F-4 tracking rig became stuck on the first pass over the crater repair (Photo 53). Photo 54 shows the tear in the membrane and a 5-in. rut left by the one pass. No further traffic was applied to this lane. Figure 5 shows typical cross-section data and the elevation of the T-17 used in the layers.

40. Discussion. The WES blended material performed the same as the 0-32 mm German crushed aggregate, that is, it was very unstable. This material needs more fines added or chemically stabilized before it can be used as a crater repair material.

- d. To use the WES blended material simulating the German 0-32 mm gradation for a crater repair, it is necessary to stabilize such material with added fines or a stabilization material, such as asphalt or portland cement (Series 3, crater 1).

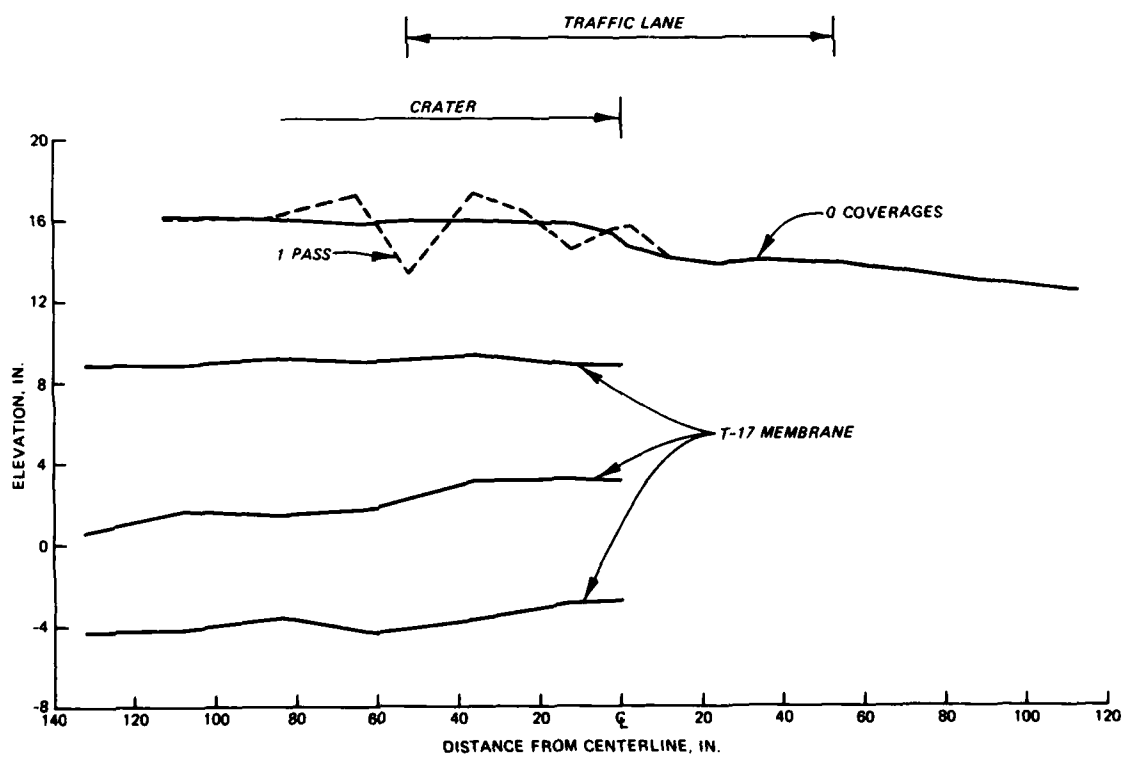
Figure 6. Cross section, crater 1, lane 2

39. Lane 2. Photo 55 shows lane 2 before traffic. The C-141 tracking rig became stuck on the first pass. The average rut depth was 5.5 in. for both ruts (Photo 56); however, the membrane did not tear. Figure 6 shows cross-section data and the elevation of the T-17 used in construction.

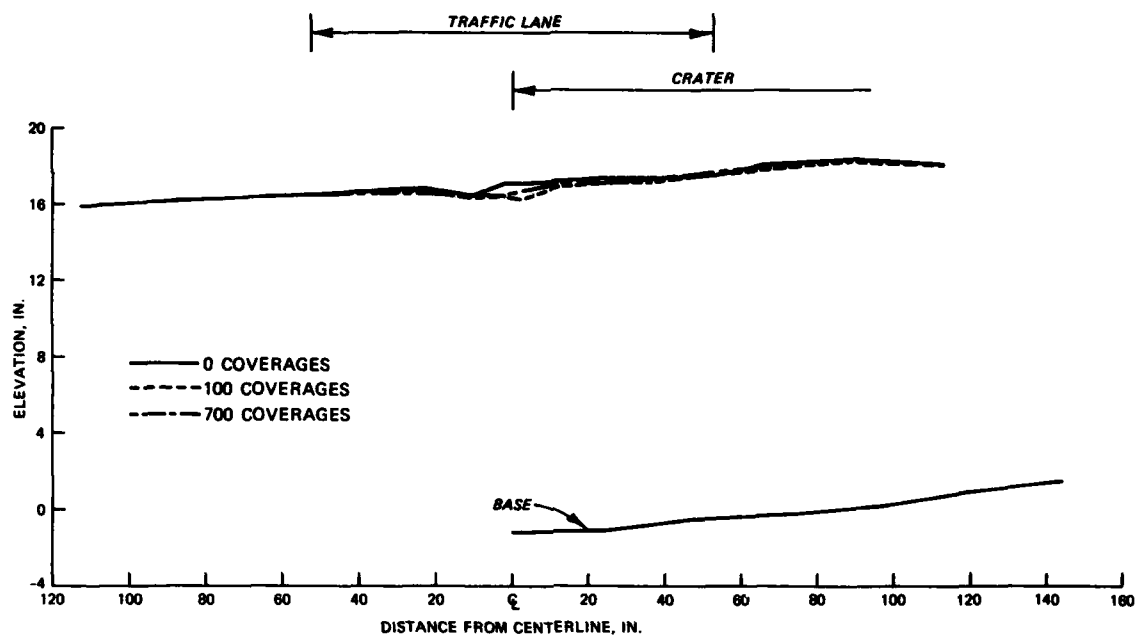
Figure 7. Cross section, crater 2, lane 1

42. C-141 traffic was applied after the F-4 traffic. The slight amount of raveling had stabilized or stopped after 340 passes or 100 coverages. At this time, the average deformation measured on a 10-ft straightedge was 0.8 in. A total of 2380 passes or 700 coverages of C-141 traffic was applied with no apparent damage. The average deformation at this coverage level was 1.0 in. (Photo 59). Figure 7 shows cross-section data for the C-141 traffic.

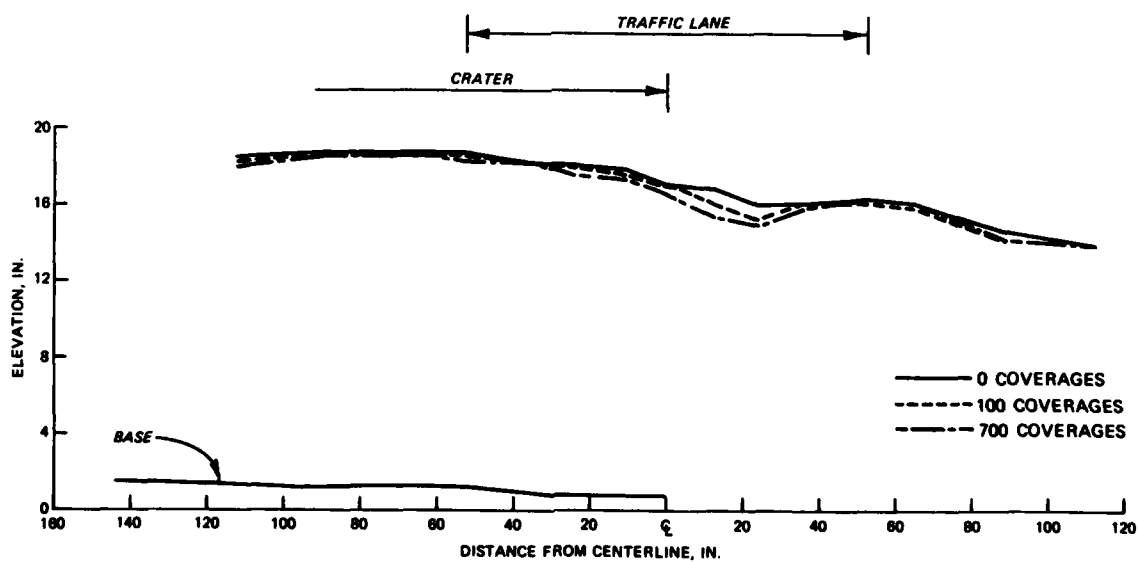
Figure 8. Cross section, crater 2, lane 2

43. Lane 2. Photo 60 shows the surface condition of lane 2 prior to traffic. As in lane 1 the only damage was the raveling of the aggregate at the surface and it stabilized after approximately 340 passes or 100 coverages (Photo 61). The deformation measured on the 10-ft straightedge averaged 0.9 in. at 340 passes or 100 coverages, 1.5 in. after 1700 passes or 500 coverages, and 1.5 in. at 2380 passes or 700 coverages, at which time traffic was stopped (Photo 62). Typical cross-section data for this lane are presented in Figure 8.

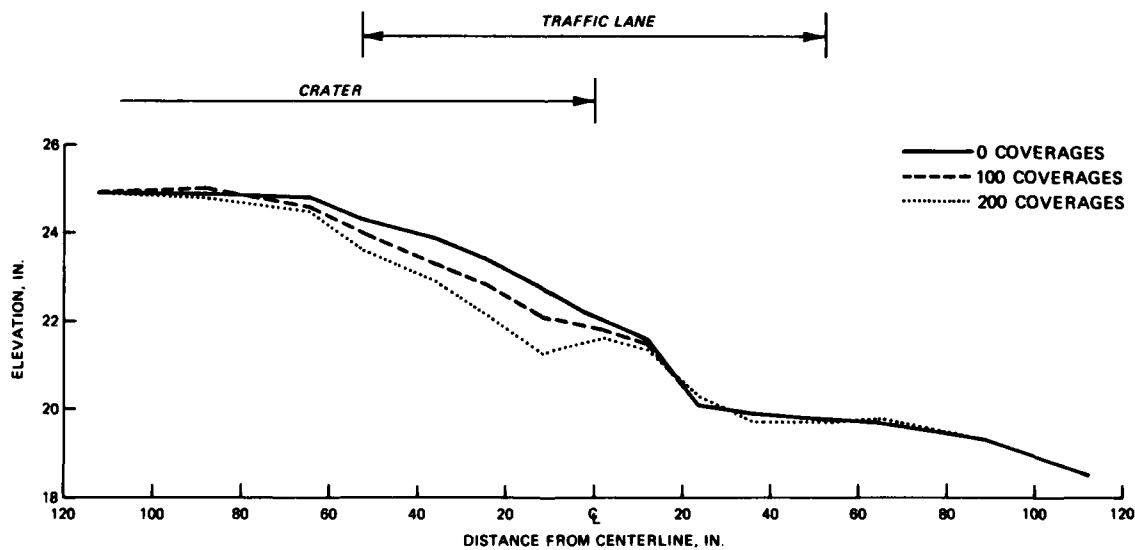
Figure 10. Cross section, crater 3, lane 2

46. Lane 2. C-141 traffic was started 22 hr after placement of the grout. Photo 67 shows the condition prior to traffic. Cracks along the edge of the crater started after 20 passes. After 102 passes or 30 coverages, block cracks started to develop inside the crater repair and minor spalling appeared on the west end. The surface started to deteriorate and consolidate at 136 passes or 40 coverages, and at 204 passes or 60 coverages the grout was approximately 0.5 in. deep (Photo 68). At 340 passes or 100 coverages approximately 0.5 in. of grout was displaced from an area 2 by 6 ft on the west end and from an area 2 by 3 ft on the east end. Consolidation under traffic and grout displacement resulted in a 2.75-in. maximum rut at this coverage level. Consolidation and grout displacement continued under traffic after 578 passes or 170 coverages. The maximum deformation was 3 in. inside the traffic lane, with loose aggregate (limestone) at each end of the traffic lane. After 680 passes or 200 coverages the crater repair was completely broken up with a 3-in. average deformation over the entire traffic lane. Photo 69 shows the breaks and areas where the grout was displaced. Figure 10 shows typical crosssection data for this lane.

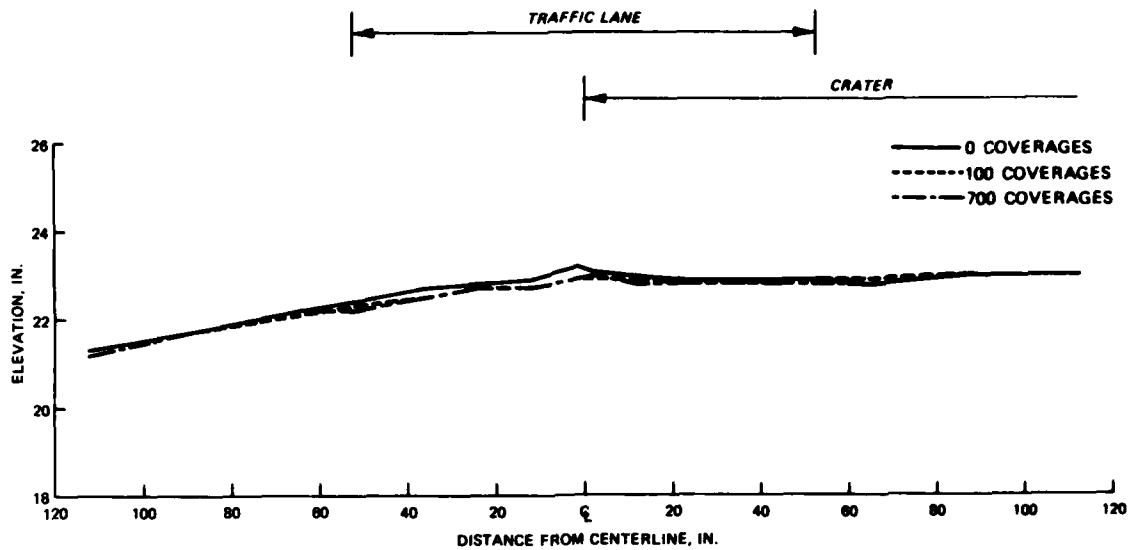
Figure 11. Cross section, crater 4, lane 1

48. C-141 traffic was started approximately 44 hr after placement of PCC. After 68 passes or 20 coverages a transverse crack appeared in the center of the crater repair. After 272 passes or 80 coverages a longitudinal crack appeared on the outside of the traffic lane in the crater repair. At 100 coverages there were three transverse cracks and the one longitudinal crack (Photo 71). At this time 7-day breaks were made on the PCC; the flexure strength was 650 psi and the compressive strength 4740 psi. Traffic was continued to 2380 passes or 700 coverages with no further damage to the PCC repair (Photo 72). Traffic was stopped 6 days before the 28-day breaks; the flexure strength was 775 psi and compressive strength 5690. Cross-section data for this lane are shown in Figure 11.

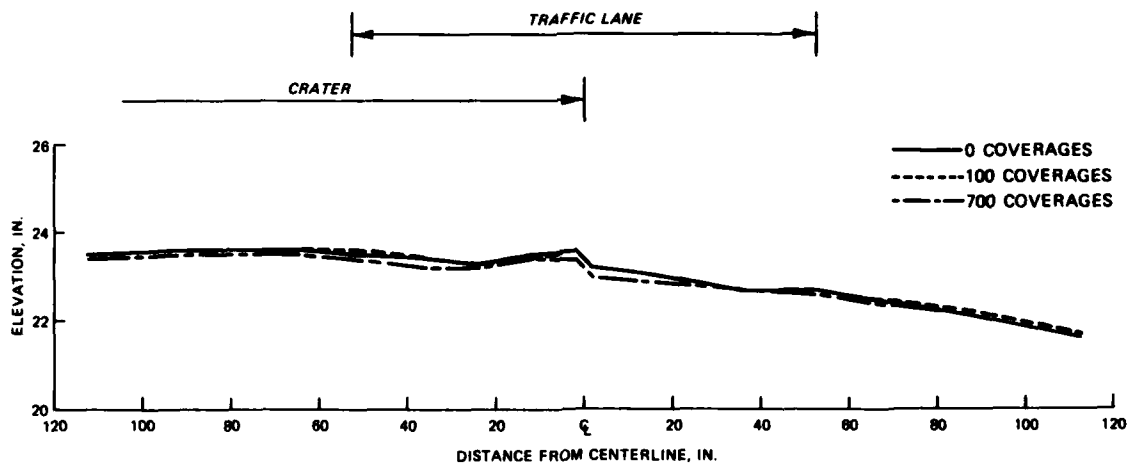
Figure 12. Cross section, crater 4, lane 2

49. Lane 2. C-141 traffic was started 24 hr after placement of the PCC (Photo 73). At 204 passes or 60 coverages one transverse crack occurred in the center of the crater repair. A longitudinal crack was noted outside the traffic lane but in the crater repair area after 340 passes or 100 coverages; no traffic was being applied to the lane when the crack was found. This may have been a shrinkage crack. After 578 passes or 170 coverages there were three transverse cracks and the longitudinal crack in the crater repair. Photo 74 shows surface conditions at 680 passes or 200 coverages. This was the coverage level when the 7-day breaks, mentioned in lane 1, were broken. Traffic continued to 2380 passes or 700 coverages with only a minor amount of additional cracks (Photo 75). Figure 12 shows cross-section data for this traffic lane.

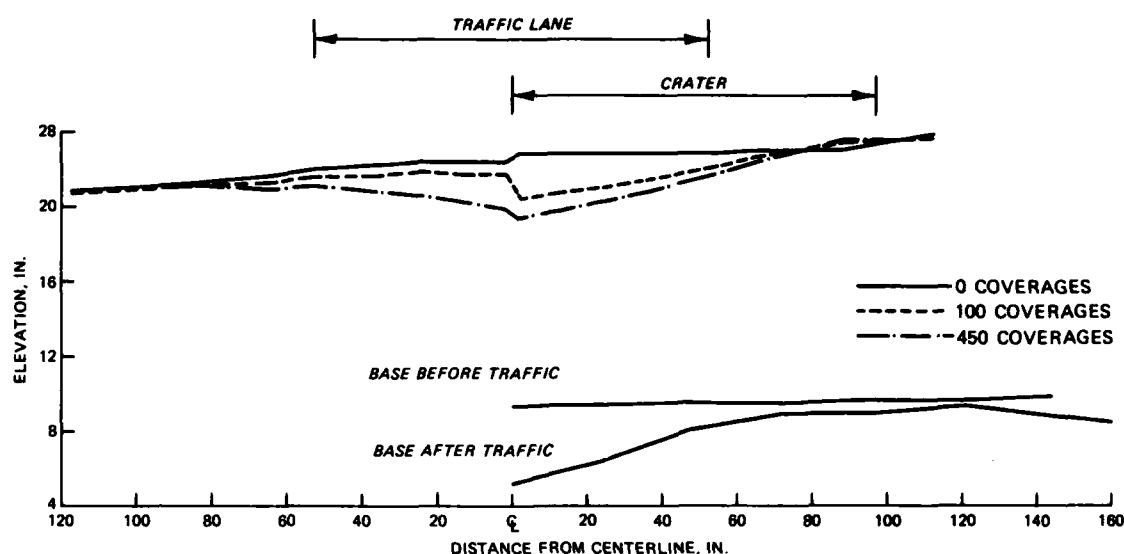
Figure 13. Cross section, crater 5, lane 1

52. With the start of C-141 traffic the washed gravel base consolidated at a faster rate. After 170 passes or 50 coverages the deformation averaged 1.5 in. The movement of the crossties stopped at this coverage level because C-141 traffic was placed in lane 2 prior to lane 1 and the traffic in lane 1 produced tension on the crossties with a slight bow up in the middle of the crater repair. The average deformation was 2.0 in. after 340 passes or 100 coverages. At 612 passes or 180 coverages cold mix was placed in the west end of the traffic lane to make a smooth transition between the crater repair and the AC over JC pavement. There was a 3-in. difference in elevation in the area where the cold mix was placed and the AC over JC pavement. After 918 passes or 270 coverages the average deformation was 2.6 in. Traffic was stopped after 1530 passes or 450 coverages; the average deformation was 3.2 in. (Photo 78). The cross-section data for lane 1 shown in Figure 13 indicate deformation in the pavement outside the crater repair. This could have been due to the lack of load transfer between the crossties and the other pavement. Figure 13 also shows the consolidation of the washed gravel base.

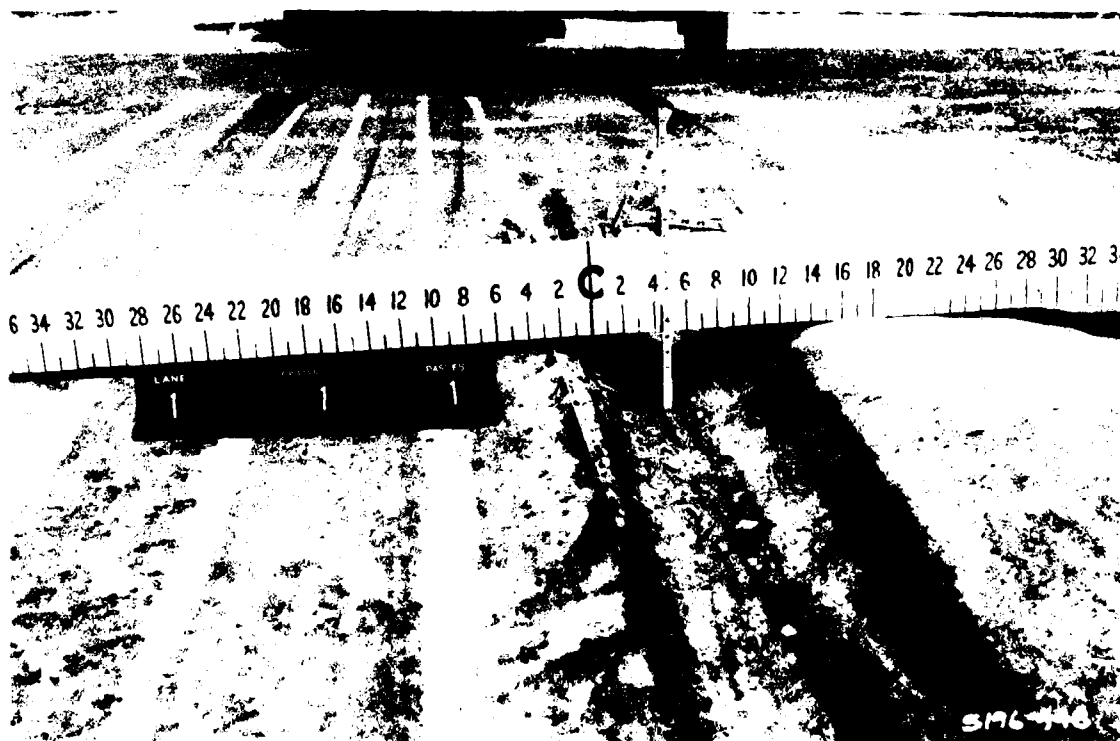
Photo 54. Damage caused by one pass of the F-4
